Name Of Dam: LAUREL CREEK
Location: GRAYSON COUNTY
Inventory Number: VA 07704 ✓

PHASE I INSPECTION REPORT NATIONAL DAM SAFETY PROGRAM

APRIL 1981

Name of Dam: Laurel Creek Dam
State: Virginia
Location: Grayson County
USGS Quad Sheet: Middle Fox Creek, Virginia
Stream: Laurel Creek
Date of Inspection: 22 April 1981

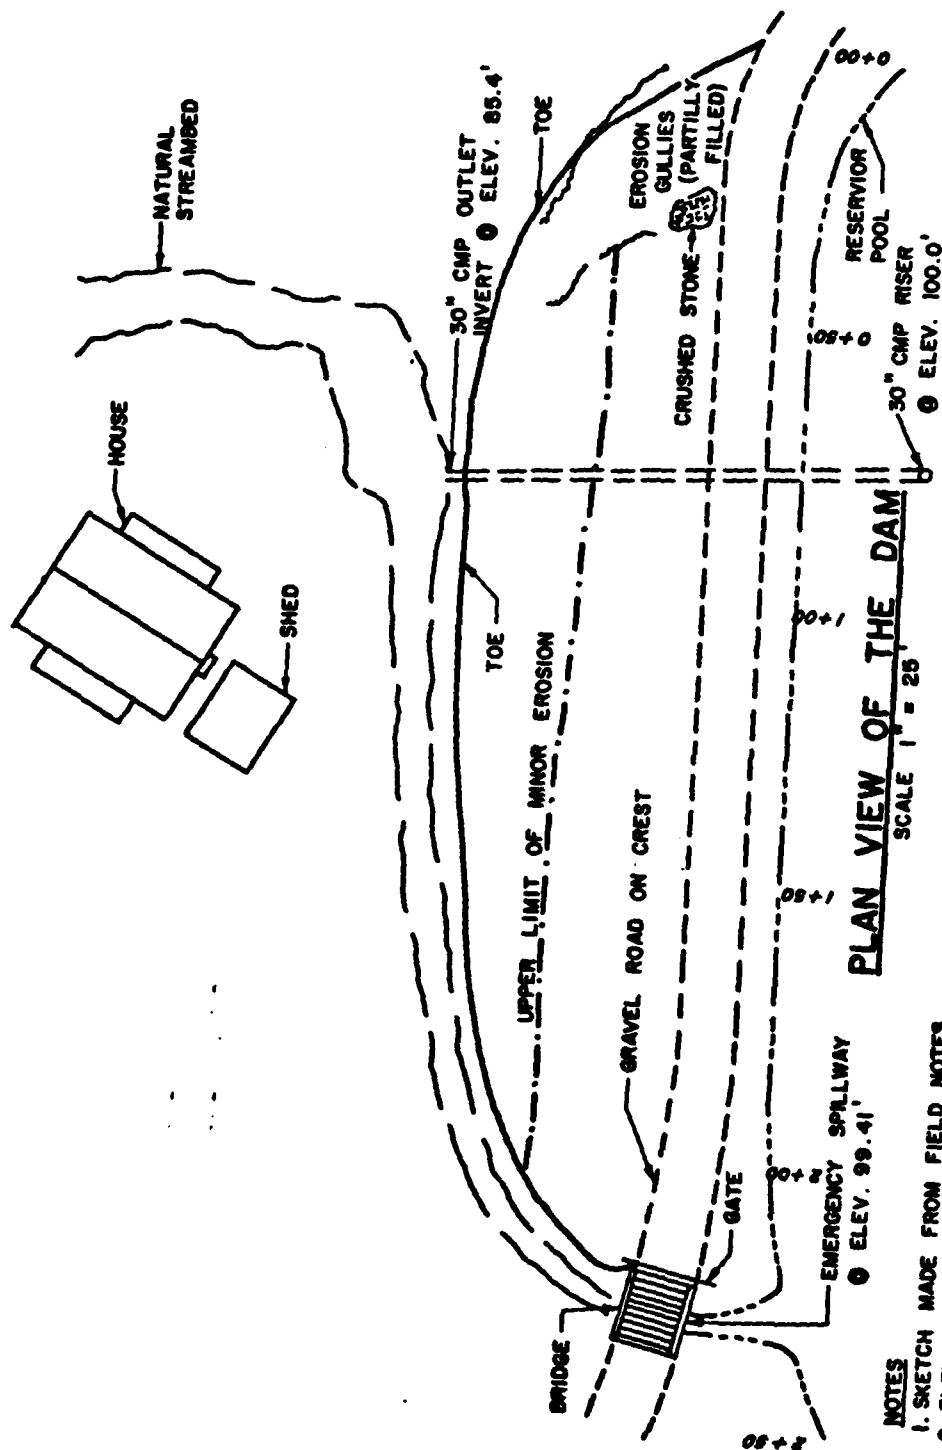
PLAN VIEW OF THE DAM

3.1.2 Embankment: The embankment is in good condition. Sketches showing a plan view, a cross section, and a profile of the crest are provided on Plates II and III, Appendix I. An overall view of dam is provided at the beginning of the report.

A seep is located on the downstream toe approximately 30 feet left of the principal spillway outlet pipe. The flow is barely noticable and is discolored (rust colored) with iron bacteria. A wet area extends along the toe from the seep to the outlet pipe. (See Plate II, Appendix I and Photo No. 9, Appendix II).

b. The seep and the wet area should be monitored for any increase in flow or turbidity during periodic inspections. If any increase in flow or turbidity is noted without an explanation the services of a geotechnical engineer should be obtained to investigate the causes of the increases.
